ANDRZEJ KOTYRBA*, ANDRZEJ KOWALSKI**

Linear discontinuous deformation of A4 highway within mining area “Halemba”

LINEAR DISCONTINUOUS DEFORMATION OF A4 HIGHWAY WITHIN MINING AREA “HALEMBA”

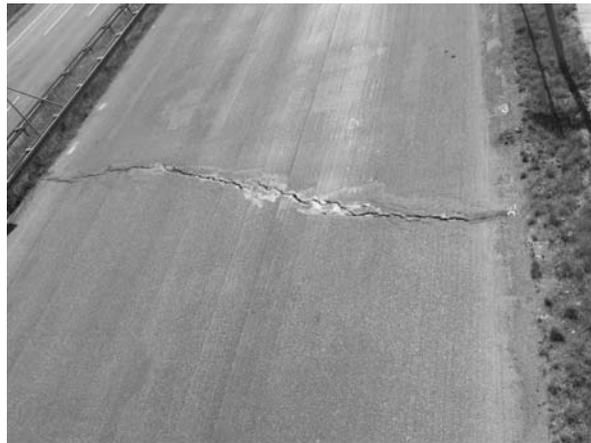
In the year 2005, less than one year after the road of the A4 highway had been completed, within the section from km 327+524 to 327+548 such discontinuities as fissures and stages as well as structures consisting of them occurred within its roads. The section where the above mentioned discontinuities occurred is located within the area of parking place Halemba-Wirek. In the area adjacent to the highway and parking place Halemba discontinuities were noticed earlier. They occurred in the forest area to the south of parking place Halemba and within the area of parking place Wirek (to the north of the road of the highway). The damages of the A4 highway in km 327+524 – 327+548 (respectively fig. 1.1 and 1.2) arose before August 2005, first as roadways folding, but later they converted into stages and fissures.

Fig. 1.1. Discontinuity on southern roadway of A-4 – direction Kraków

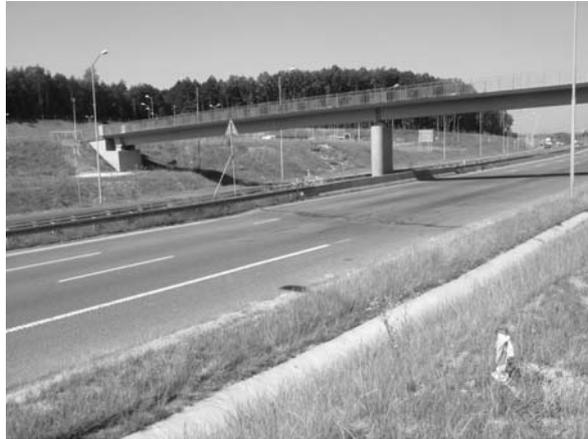
The increase of folding altitude along a roadway of A4 geodetically measured from May to August 2005 amounts to:

- on the southern roadway (direction Kraków) 11–14 mm,
- on the northern roadway (direction Wrocław) 17–18 mm.

Fig. 1.2. Discontinuity on northern roadway of A-4 – direction Wrocław

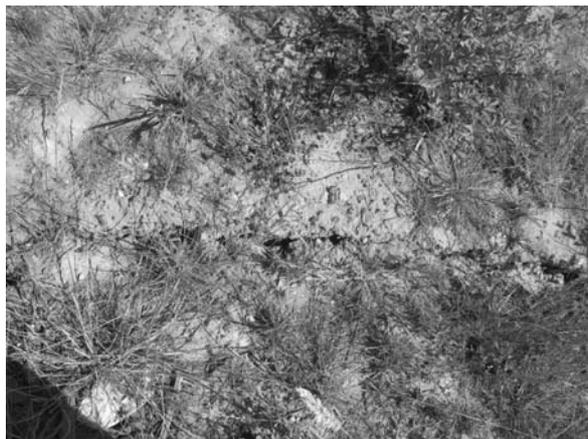
At the end of August 2005 on the southern roadway of the A4 folds converted into two fissures with their widths from 1–2 cm each. Directions of discontinuities were diagonal to the highway axis with their angles of about 66° (SW-NE). On their continuation within the area outside the roadways there could be found fissures with their width from 4–5 cm and stages of an average height of 7 cm and throw to the East (fig. 1.3).

Fig. 1.3. Fissure in soil at place adjacent to roadway A4 from North (Wirek parking place)

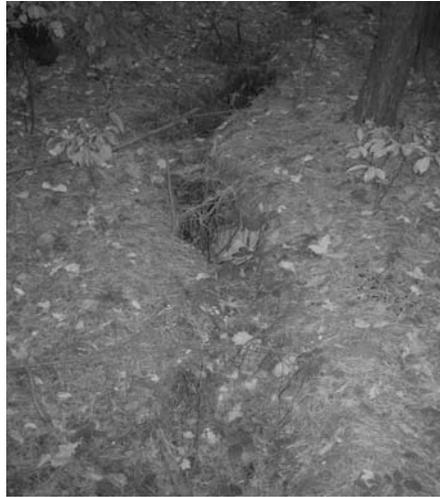
Earlier in the year 2003 during conducted monitoring, in the forest area to the south of roadway the occurrence of discontinuities was noticed. There were three parallel wide fissures located 15–20 meters off, with their directions SW-NE. Their lengths amounted to about 100 m, widths to 0.5 m and depths to 1.5 m (fig. 1.4). Signs of these continuities were also visible on the slope of excavation for Halemba parking place construction.

Within the area of parking place being constructed (after the completion of roadway of the A4) in May 2005 after abundant rain, there occurred discontinuities in form of hollows (trench alongside underground fissure) accompanied by sinks with their dimensions of about 2 meters (fissure chutes). Locally, in the near-surface soil layer fissures similar to the one from the fig. 1.3 could be noticed.

Fig. 1.4. Discontinuity of soil surface in forest to South from roadway and parking place Halemba (fot. M. Grygierek)

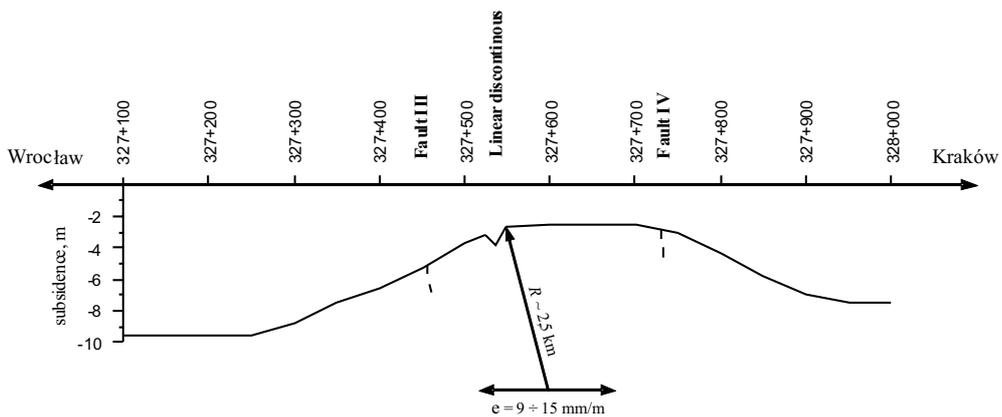
Influences of mining exploitations conducted from 1947 to 2003 are defined theoretically. Surface subsidence along the highway axis from km 327+100 to 328+000 (between faults III and IV) was presented in the fig. 4.1. Within the parking place a “subsidence crest” occurred where subsidence came to about 1.5 m, to the west and east subsidence increased to

Fig. 4.1. Subsidence of surface in highway A4 axis before commencement of construction works at area of faults III and IV, due to performed exploitation and estimated horizontal deformation ϵ

about 10 meters. Radius of convex flexure of surface numerically estimated from subsidence amounted to 2.5 meters. In the zone between faults III I IV there have occurred horizontal tensile deformations that were summing up. Within the area of discontinuity they amounted to +9.0 mm/m to +15.0 mm/m.

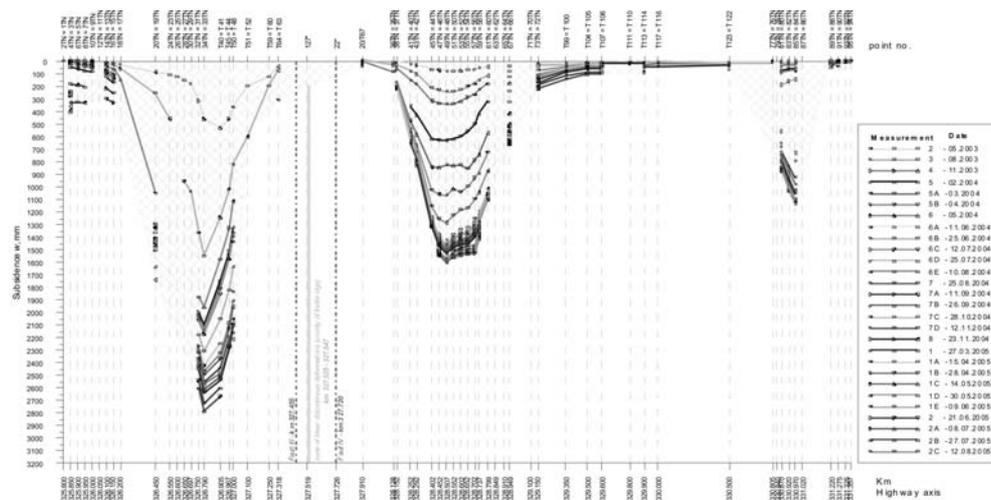
Fig. 4.2. Measured subsidence along the longitudinal axis of A4 highway in period from 03.2003 to 12.08.2005

Considering the location of parking place, most of measurement points within the zone of the highway were destroyed. Despite their lacks subsidence defined from March 2003 to August 2005 in the area of discontinuity amounted to about 0.2 m. To the west and north of the discontinuity subsidence amounted respectively in km 326+680 to 2.8 m and km 328+560 to 1.7 m. Radius of flexure estimated from subsidence amounts to about 10 km.

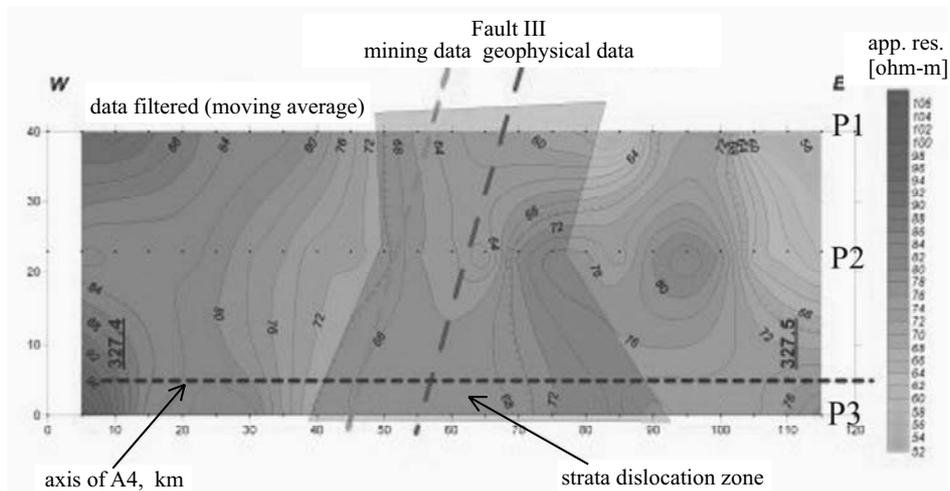
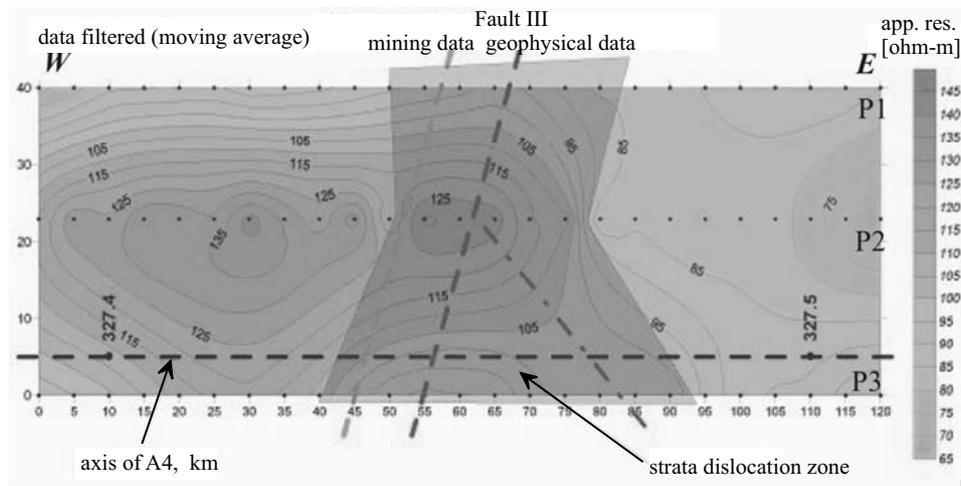
Research results such as horizontal layout of specific resistivity values of bedrocks (after their filtration) at each depth were presented in the fig. 5.1 and 5.2. Their analysis shows that array with shallower reach penetrated mainly a layer of weathered loams. It results from relatively lower level of electric resistivity value than registered with a array with deeper reach.

In iso-ohm layout for this array, dislocation zone of a fault is stated as low-resistance anomaly. In the interpretation it was assumed that it is caused by water drainage from the part of waste rock material to fissures within deeper bedrock. The layout of apparent resistance values of rocks from deeper layers of the bed is presented in the fig. 5.2. On the image of iso-ohms layout presented in the above mentioned figure, the bed of investigated area is divided into a higher-resistance part with values amounting to 100 and more ohm (in the western part) and lower-resistance part (in the eastern part) with values amounting to 80 and less ohm. Iso-ohm image at this depth is disturbed additionally by presence of outcrops of lithologically different carboniferous formations.

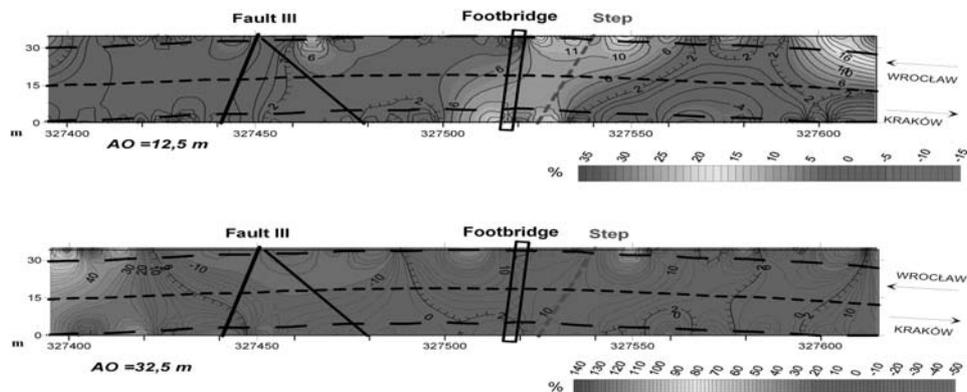
In the horizontal image of a layout of near-surface layer resistivity changes (upper part of fig. 6.2) both location of the fault III and threshold reveal a correlation with route and shape of isolines of percentage changes. However only the line of the fault is a border between areas of various symbol of resistance values changes (to the west- resistance value decreases, to the east- resistance value increases). The zone of discontinuity- threshold exposes on this image as a strip of irregular shape where resistance value increases for more than 4%.

Fig. 6.2. Maps of soil and rock apparent resistivity changes (expressed as a percentage of initial values) between III and II measurement series (upper image – subsurface soil, bottom image – bedrock)

The width of this strip is larger in its north part (roadway towards Wrocław) than in the south one (roadway towards Kraków). Assuming that dislocation zone it is an area where

resistance value increased, then in the north part it is 100 meters long and in the south part about 80 meters.

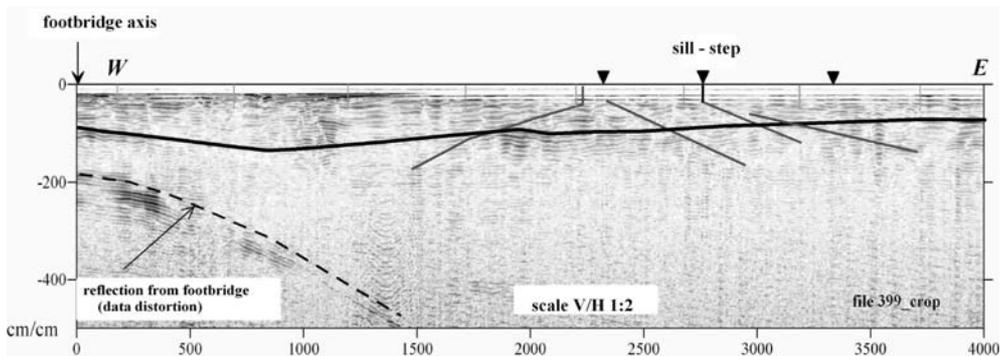
Fig. 6.3. Substrate discontinuities in the northern shoulder of A4 roadway (direction Wrocław) at area of sill in GPR image (depth section)

registrations are disturbed by strong surface reverberation from the footbridge structure. It can be distinguished only one quasi-horizontal reflective horizon on the sections, which probably corresponds with a border between road foundation and genuine bed (at the depth from 1 to 1.8 m). In the area of a threshold a few reflective horizons with diagonal course can

be distinguished (marked with red colour). They cross road foundation layer and reach a layer of genuine bed.

The above mentioned horizons have opposing dip angles. Inclinations of these horizons are not large taking into consideration superiority of vertical scale on the sections (2:1). Dip angles vary within the range from 12–20°. Such small angles of reflective horizon dips let to believe that their origin should be searched rather in a phenomenon of ground chamfer building the bed of the road than in cracks of tectonic origin. The above mentioned hypothesis is also supported by the fact that there are few discontinuity surfaces and they have opposing dips. The location of the zone where horizons may be observed correlates well with results of electro-resistance research. The highest temporal changes of the bed resistance were registered within a near-surface layer with its thickness comparable with the layer penetrated with radar.

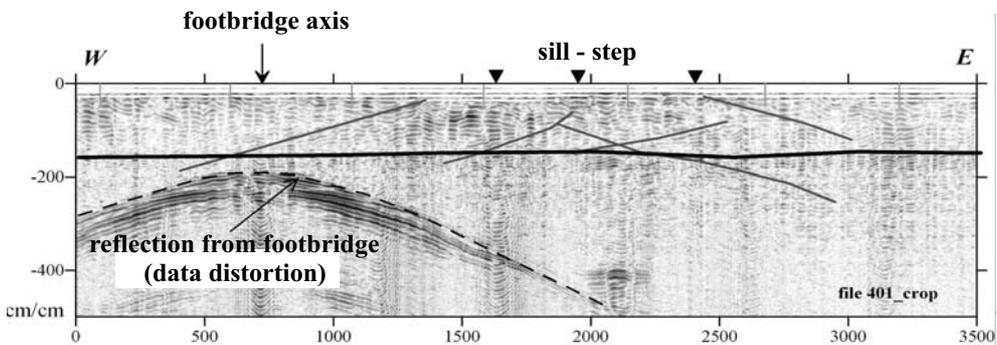
Fig. 6.4. Substrate discontinuities in the southern shoulder of A4 roadway (direction Katowice) at area of sill in GPR image (depth section)
