ELŻBIETA PIETRZYK-SOKULSKA*, JOANNA KULCZYCKA**

Impact of landfilling of red mud waste on local environment – the case of Górká

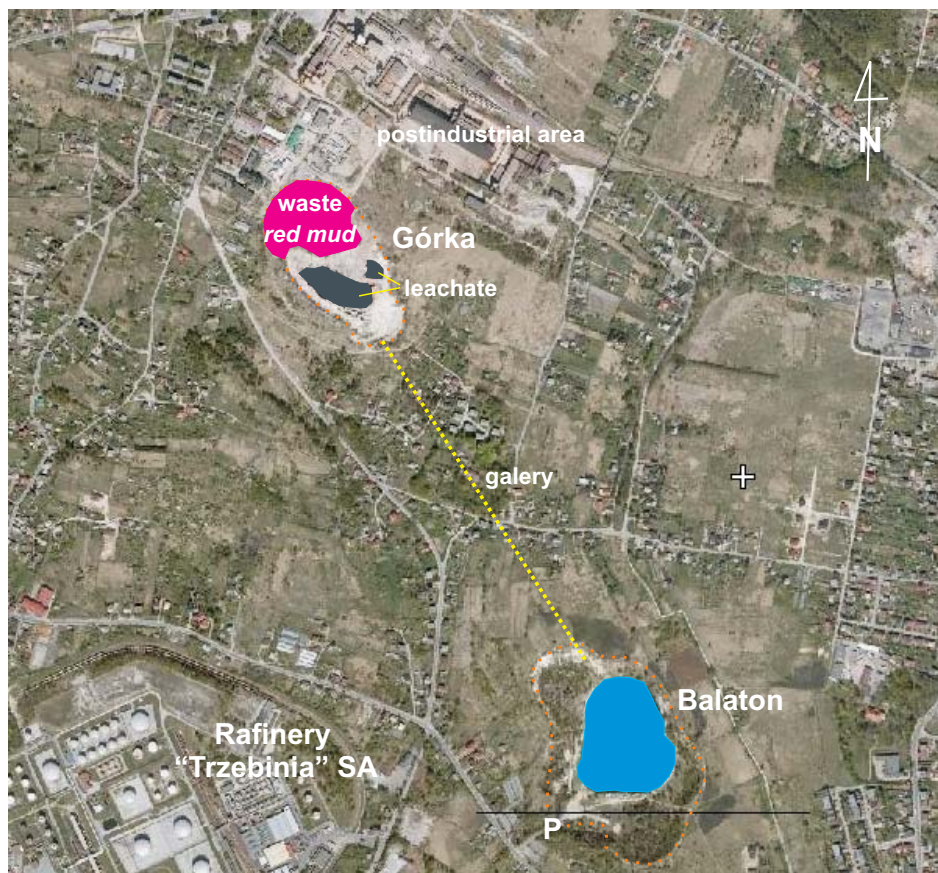
Fig. 2. View of the Górká and Balaton reservoirs in satellite map

the valours of the surrounding countryside. Górka and Balaton reservoirs are shown in Fig. 2 (satellite map) and in Fig. 3 (current).

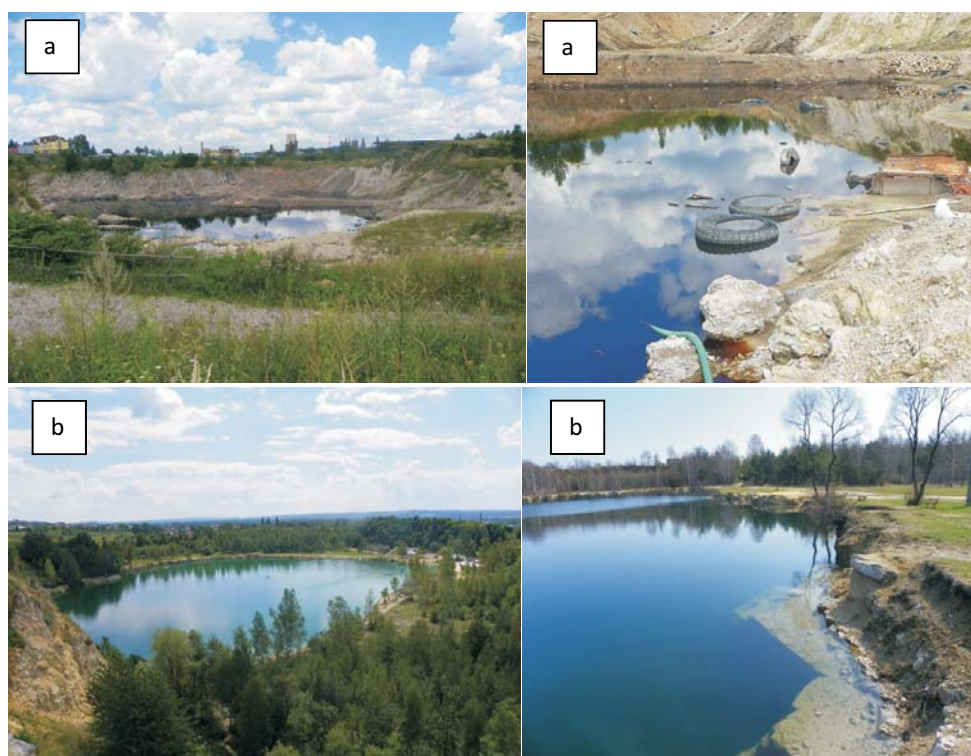
Fig. 3. Górka (a) and Balaton (b) reservoirs (photos by E. Pietrzyk-Sokulska)

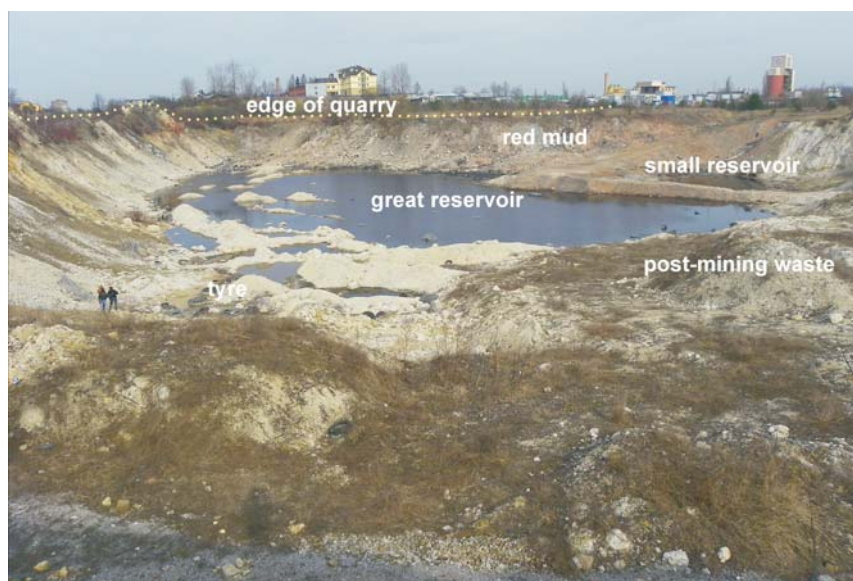
Fig. 4. View of the Górka reservoir after pumping of leachate (photo by E. Pietrzyk-Sokulska)

The excess leachate from the landfill was initially discharged by gravity into an existing tunnel, which leads to the nearby Chrzanów wastewater treatment plant. In 1991, a discharge of leachate was stopped due to damage of the collector and the biological part of the treatment plant in Chrzanów. It need to be noticed, that in 2000 a substantial rise in the level of leachate in Górka reservoir caused by the clogging of a discharge mine shaft was observed. This has led to spillage out the leachate over the surrounding terrain, creating a health and safety risk for the local community and environmental. Meanwhile the fireproofing materials company, which had been the main land user, had gone out of business, leaving their unoccupied properties in a state of collapse, ultimately leading to the municipality of Trzebinia taking over the supervision of the area. The municipality also undertook repairs to the water basin in Górka to reduce the risk of spillage and leachate contamination in the surrounding area. The remedial actions were taken in order to a preventing an environmental catastrophe. This required pumping and neutralisation of the alkaline leachate and removal of the silt from the adit to drain leachate safely by gravity to a local stream. As a result of pumping out the leachate, their level went down by almost 12 m – Fig. 4.
