ANDRZEJ KOTYRBA*, ANDRZEJ KOWALSKI**

Linear discontinuous deformation of A4 highway within mining area “Halemba”

LINEAR DISCONTINUOUS DEFORMATION OF A4 HIGHWAY WITHIN MINING AREA “HALEMBA”

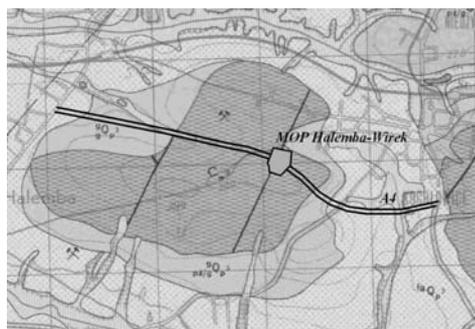
Fig. 2.1. Location of parking place Halemba – Wirek on geological map

point of view roof carboniferous layers are formed by Orzeskie beds. In carboniferous formations there can be distinguished about twenty hard coal seams (Rudzkie and Siodłowe beds) depositing alternately in siltstones and sandstones layers. The roof of Orzeskie beds within the parking place is cut by a fault with SW-NE direction. The direction of the fault throw is not indicated on the detailed geological map (fig. 2.1).

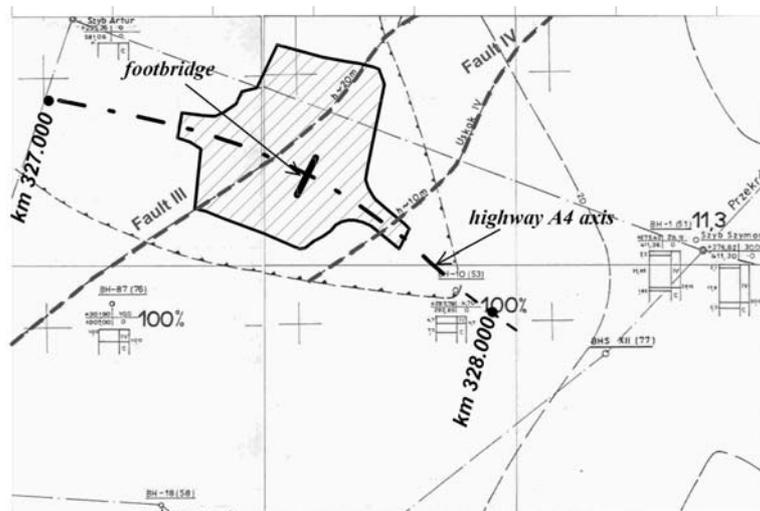
Fig. 2.3. Location of parking place Halemba-Wirek on map of overburden thickness (according to geological documentation of coal deposit)

On the maps documenting hard coal deposit in the area of parking place there are noticed two faults named fault III and IV, with their throws respectively 20 and 10 m (fig. 2.3). To the north (outside parking area) the size of throws of these faults increases.

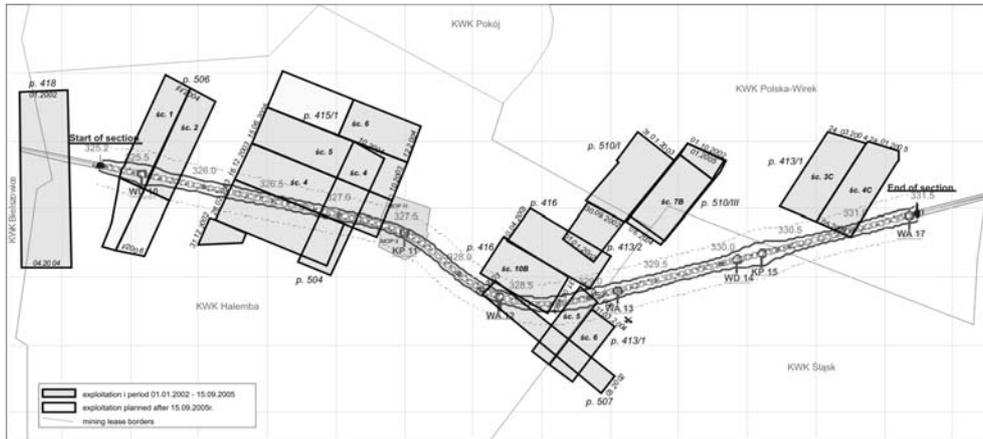
Fig. 3.1. Layout of coal exploitation performed in years 2003–2005 at area of A4 highway

415/1 and 501 (in the west) and 416 (in the east). Depths of exploitations were in the range from 650 m to 812 m. Thicknesses of exploited seams varied from 2.0 to 3.5 m (fig. 3.1).

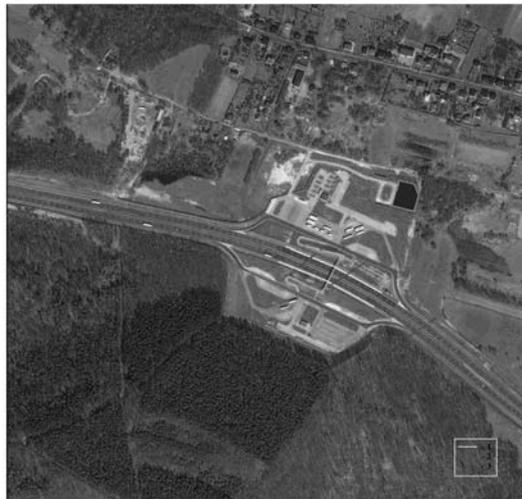
Damages of roadway structure (discontinuities) are the reasons of geophysical research continuation in the area of fault III (measurement series II I III) in the year 2005. They were localized about 85 meters to the east from indicated line of fault III. Research covered the section of about 200 meters, including the area of I series measurements as well as the area of observed roadway damages in the vicinity of a footbridge. Research localization is presented in the fig. 6.1.

Fig. 6.1. Location of geophysical measurements in the year 2005 on satellite image background
1 – measurement profiles, 2 – faults, 3 – discontinuity in asphalt roadways
