GÖKHAN EKİNCİOĞLU¹

Non-destructive methods determination of thermal shock resistance of natural building stones applied with different water repellent chemicals on their surfaces

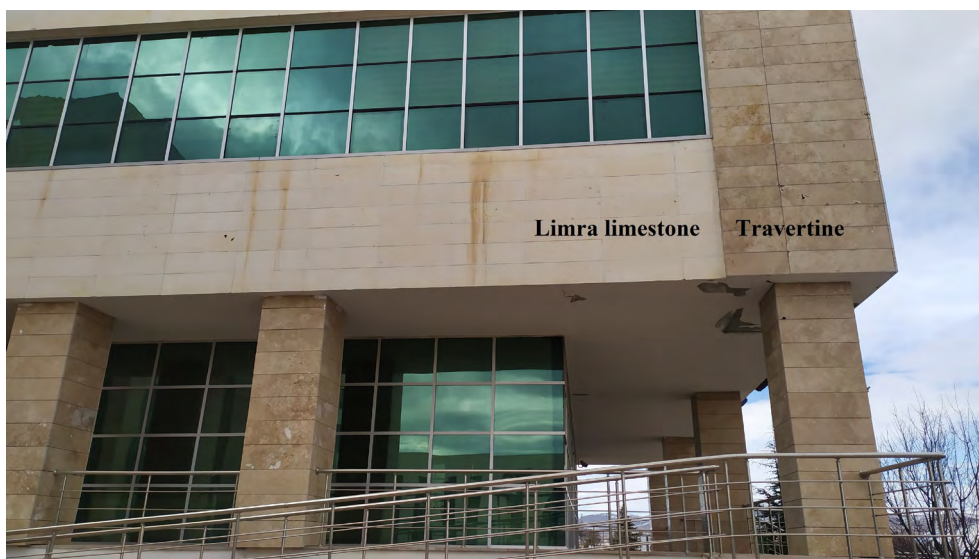
Fig. 1. View of a building where limra limestone and travertine are used as exterior cladding (Kırşehir Ahi Evran University)

surface of natural stones due to the effects of acid and sulfate in the air and water. As a natural consequence, color and pattern distortion is observed in the structure of coating materials (Figure 1) (Çetin 1998; Butler and Likens 2019; Yeşilay 2019). Chemical reactions resulting in wear and color changes are more frequently observed, especially in carbonate rocks. Figure 1 shows the appearance of a building where limra limestone and travertine are used as exterior cladding, and color changes are also observed in the limra limestone slabs.

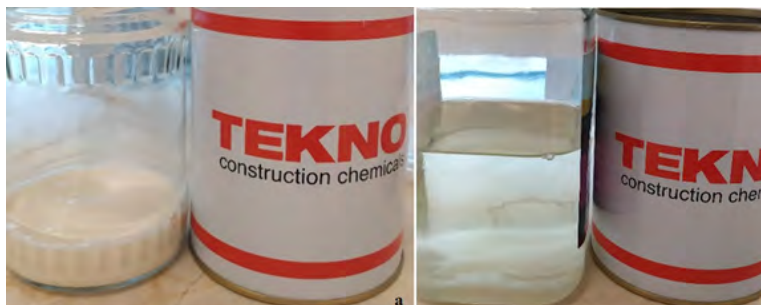
Fig. 2. Appearance of water-repellent chemicals
a) water-based water repellent, b) solvent-based water repellent

The obtained natural stones were brought to the natural stone analysis laboratory of the Kaman Vocational School of Ahi Evran University's in Kırşehir, where samples measuring $2 \times 10 \times 10$ cm were prepared. A total of thirty samples were prepared and five samples from each group were used. After sample preparation, two different water-repellent chemicals were provided from the TEKNO Building Chemicals company: one water based and the other solvent based. The water-based repellent chemical has a thick consistency and is white in color (Figure 2a), while the solvent-based chemical is more fluid and has a transparent appearance (Figure 2b).

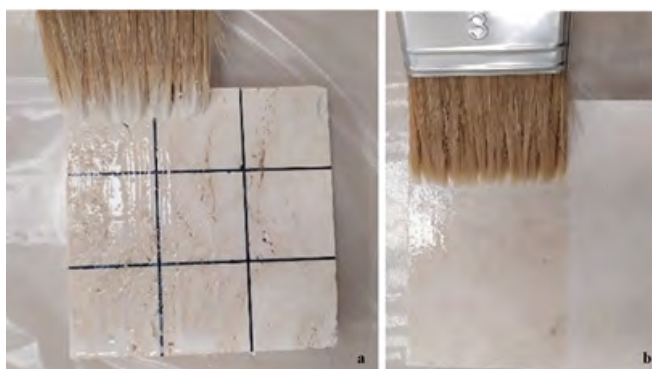
Fig. 3. Water-repellent chemical application process
a) water-based water-repellent chemical application, b) solvent-based water-repellent chemical application

to enhance the impregnation performance of the water-repellent chemicals. Water-repellent chemicals were applied to all surfaces of the samples with a brush, in two coats with a 4-hour interval, in dimensions of $2 \times 10 \times 10$ cm (Figure 3). The application was conducted at 20°C and 40% humidity, in accordance with the application conditions of the TEKNO company (TEKNO Construction Chemicals Catalog 2022).

Both chemicals resulted in a shiny appearance on the surfaces of the samples after their application. However, as the water repellency absorption was completed, the surfaces returned to their previous appearance. No significant color change was observed upon examination with the naked eye. After the application, samples were left for a period of approximately one week in order to dry.

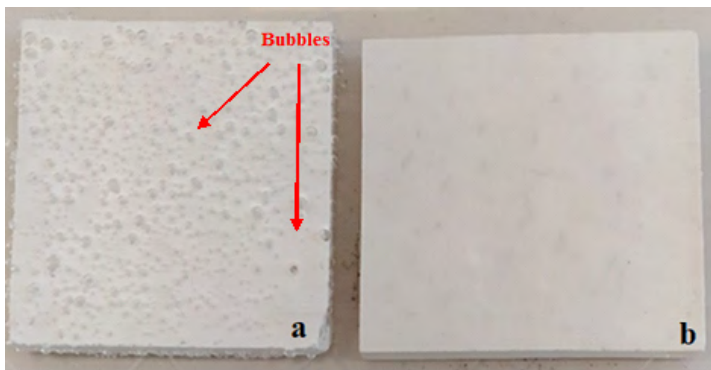
Fig. 4. The appearances of examples with and without water repellent applied in water a) without water-repellent chemical, b) with water-repellent chemical

Pure water absorption tests were conducted on the samples before the thermal shock experiments with salt solution to determine their hydrophobicity. Figure 4a presents an example of a sample without the application of a water-repellent chemical; Figure 4b presents an example with the application of a water-repellent chemical. The sample without the application of a water-repellent chemical releases air as a result of water entering its pores. This was observed with air bubbles formed on the surface of the stone. However, no air bubbles were observed on the sample with the application of a water repellent chemical.

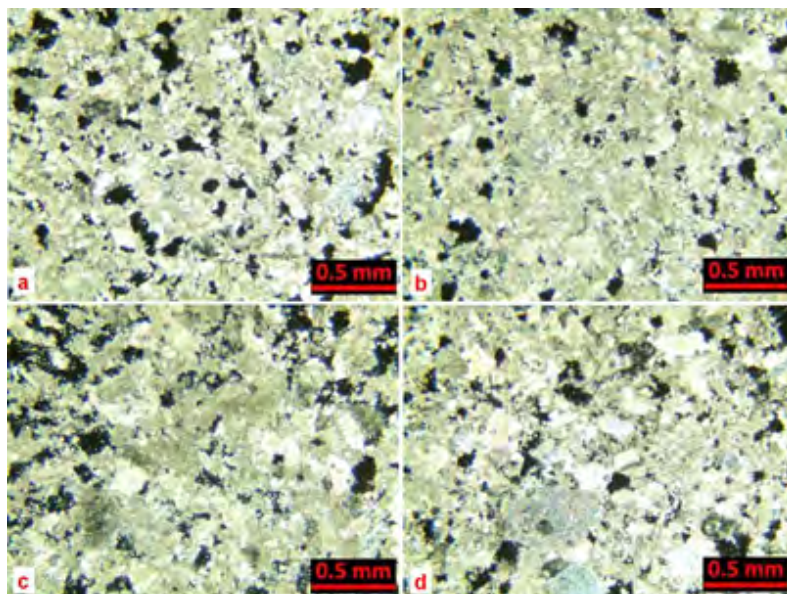
Fig. 5. Thin-section double-nicol images of limra limestone samples
a) original sample, b) sample without water-repellent chemical after thermal shock,
c) sample with solvent-based water-repellent applied, d) sample with water-based water-repellent applied

laboratory of the Department of Geological Engineering at Ahi Evran University in Kırşehir. The cross-polarized images of the limra limestone samples obtained from the thin-section examinations are shown in Figure 5, and those of the travertine samples are shown in Figure 6.

Analyzed in thin sections, both rocks were observed to have fine-grained calcite minerals (sparite) and abundant pores, indicating that they were limra limestones (Figure 5a and Figure 6a). In addition to the original rock samples, thin-section analysis was also conducted on the samples subjected to thermal shock tests with and without the application of water repellents in order to determine their effects (Figure 5b, c, d and Figure 6b, c, d). However, no data reflecting the protective properties of water-repellent chemicals could be obtained from the thin-section analysis.

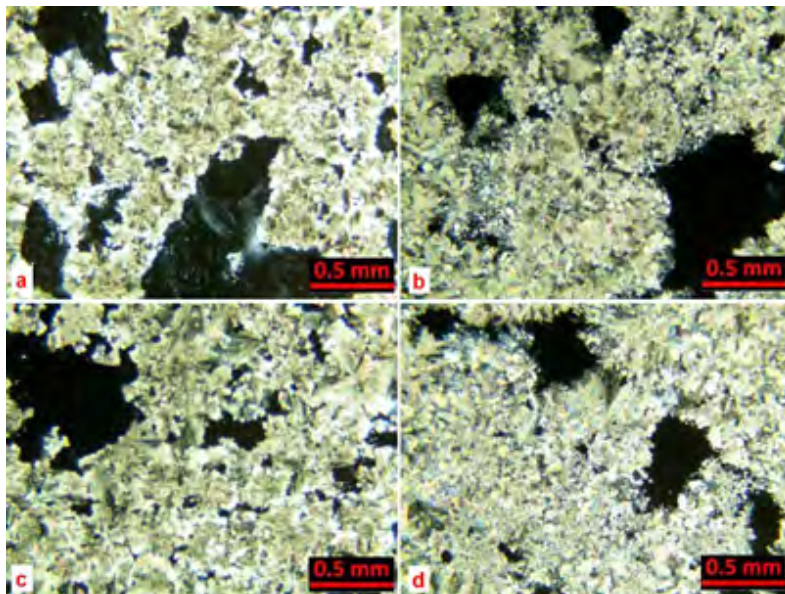
Fig. 6. Thin-section double-nicol images of travertine samples
a) original sample, b) sample without water-repellent chemical after thermal shock,
c) sample with solvent-based water-repellent applied, d) sample with water-based water-repellent applied

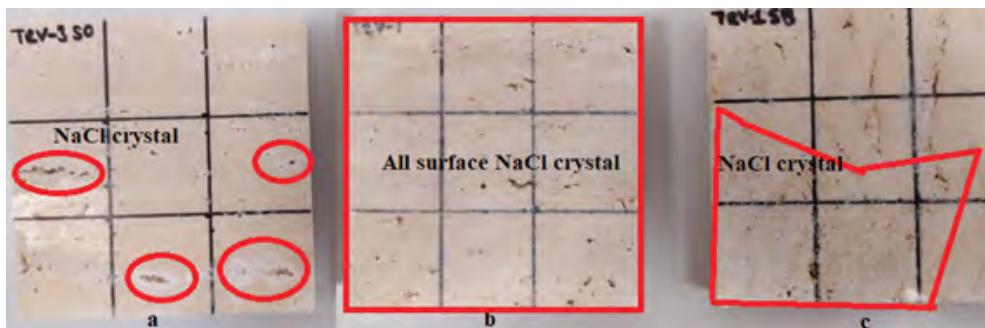
Fig. 7. View of travertine samples after thermal shock cycle
 a) solvent-based water-repellent chemical applied, b) no water-repellent chemical applied,
 c) water-based water-repellent chemical applied

The mass increase in limra limestone and travertine samples without a water-repellent chemical was higher than in samples with a water-repellent chemical applied. The solvent-based water-repellent chemical has better pore-clogging properties and makes the surfaces more hydrophobic than the water-based one, in both limra limestone and travertine samples. This was observed in the travertine samples taken out of the oven (Figure 7). Figure 7a shows fewer salt crystals around the pores compared to the examples given in Figure 7b and Figure 7c. In Figure 7b, there is salt crystallization all over the surface since there is no chemical applied. In Figure 7c, more salt crystallization was observed than in the example in Figure 7a, but less compared to the example in Figure 7b. The results observed in Figure 8 are also supported by the mass increase values given in Table 4. The colors of salt crystals and limra limestone are similar, so they are not clearly visible in photographs. Therefore, only travertine images are provided.

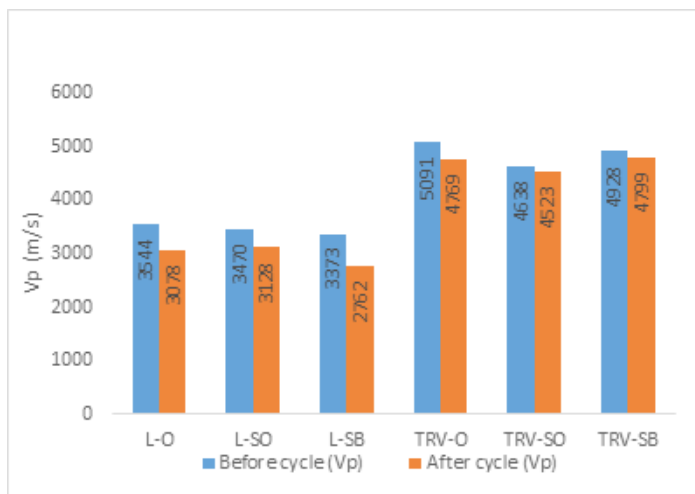
Fig. 8. Ultrasound velocity (V_p) changes before and after thermal-shock cycles

When the data obtained after the measurements are examined, a decrease in V_p rates was observed due to the damage caused by salt crystallization. The highest damage occurred in L-SB samples. The least damage was observed in TRV-SO and L-SO samples. It was observed that water-based water repellent increased the damage in the limra limestone samples. However, it could provide some protection in travertine samples, although not

as much as solvent-based water repellent. The changes in the ultrasound velocity (V_p) after cycles are given in Figure 8.

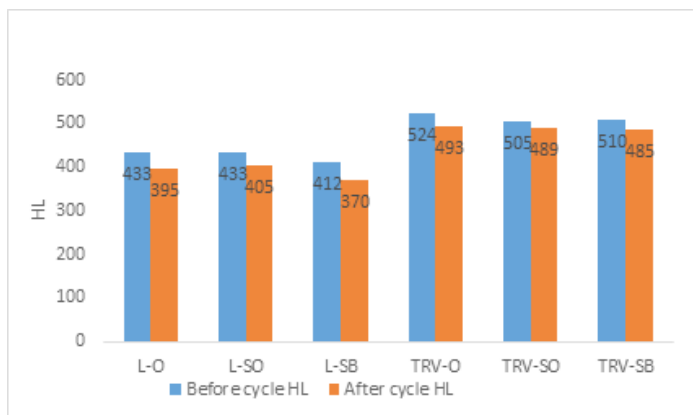
Fig. 9. Leeb hardness (HL) change rates after thermal shock cycles

In order to obtain Leeb hardness (HL) values, 15 readings were made on each sample and the arithmetic averages were calculated after 75 readings in total for each group. When the data obtained after the measurements was examined, a decrease in HL values was ob-

served due to the damage caused by thermal shock and salt crystallization. The highest damage occurred in the L-SB samples, while the least damage was observed in TRV-SO and L-SO samples. It was observed that the water-based water-repellent chemical increased the damage in the limra limestone samples. However, although it was not as effective as the solvent-based water repellent chemical in the travertine samples, it provided some protection. Figure 9 shows the ratio of changes in HL values after cycles.

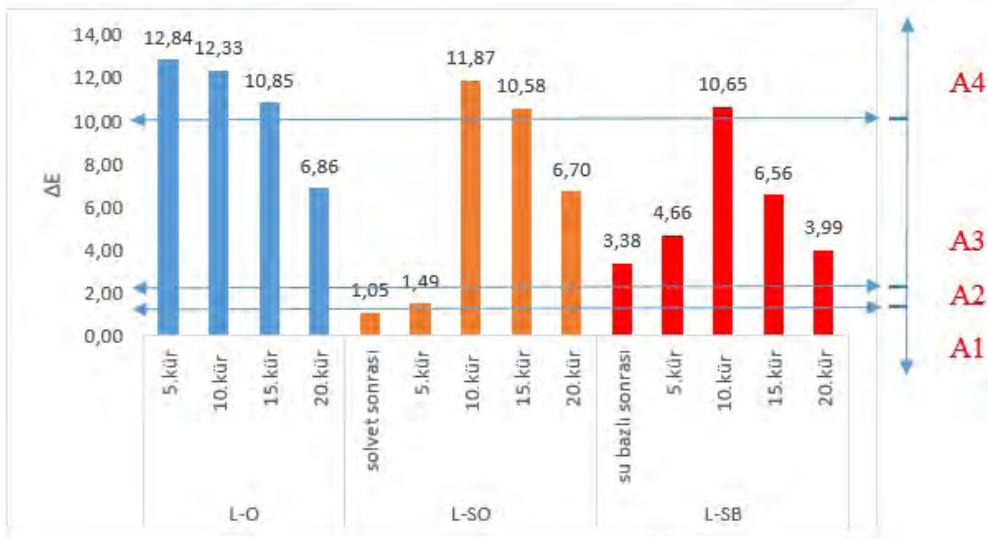
Fig. 10. Color changes and classes in limra limestone samples (L-O, L-SO, L-SB)

In the L-O rock group, a change in the A4 class was observed in the ΔE value after the 5th cycle. By the 20th cycle, the difference between the original color value and the result

had decreased, and it was classified as A3. As a result of thermal shock cycles in L-O samples, the surface wears away, and the original color of the underlying rock appears, causing a decrease in ΔE values. In L-SO samples, it was determined that the ΔE value was close to the A1 class after solvent-based water repellent application. It was also observed during the examination that the color change was quite low as a result of solvent-based water-repellent chemical application. After thermal shock experiments, the water-repellent surface-protector effect was observed up to the 5th cycle. Although the color difference class was in A2 ($\Delta E = 1.49$), it was determined to be close to the A1 class. Color changes and classes in limra limestone samples (L-O, L-SO, L-SB) after thermal shock cycles are shown in Figure 10.

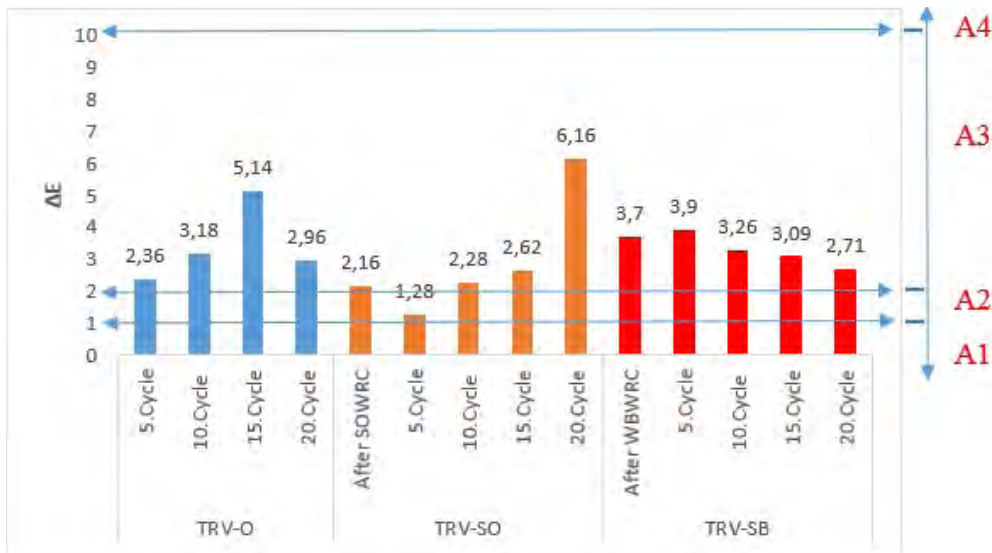
Fig. 11. Color changes and classes in travertine samples (TRV-O, TRV-SO, TRV-SB)

Depending on the rock structure, color changes in travertine samples were lower than those in limra limestone samples. In samples of TRV-O on which no water-repellent chemicals were applied, the color difference increased in the cycle (2.36–3.18–5.14), but a new surface emerged due to wear that occurred on the surface, similar to the limra limestone samples. Therefore, the color-difference value decreased to 2.96. Although the color class of samples treated with solvent-based water-repellent chemicals is A3, it is very close to class A2. No clear color change was observed after the application of water repellent chemicals through visual inspection. No clear color change was observed in TRV-SO samples

until the 15th cycle. However, the color change value increased after the 15th cycle (6.16). According to the obtained data, it can be said that the solvent-based water-repellent chemical showed its effect up to the 15th cycle. In TRV-SB samples, the color change after applying water-based water-repellent chemicals was higher compared to TRV-SO samples. The color-difference value increased in the 5th cycle. However, the difference in color values decreased due to wear that occurred on the surface later. The color changes and classes that occurred in the travertine samples (TRV-O, TRV-SO, TRV-SB) after thermal-shock cycles are shown in Figure 11.

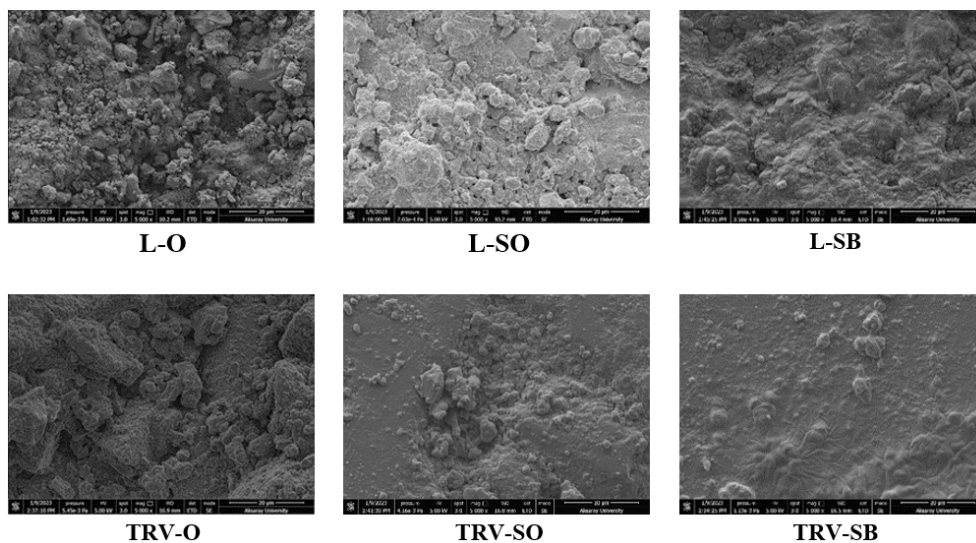
Fig. 12. SEM images of water-repellent and non-water-repellent samples before thermal shock

During the study, water-based and solvent-based water-repellent chemicals were applied to limra limestone and travertine samples, and SEM analyses were performed before and after thermal shock. In addition, EDX analyses were conducted to reveal the effect of salt solution on the water-repellent chemicals after thermal shock. SEM imaging was conducted using the scanning electron microscope (SEM) at the ASÜBTAM laboratory at Aksaray University during the analyses. Prior to the thermal shock experiments, water-repellent chemicals were applied to the limra limestone and travertine samples, and SEM images were taken (Figure 12). After SEM examinations, it was observed that there were smooth surfaces on the samples where water-repellent chemicals were applied.

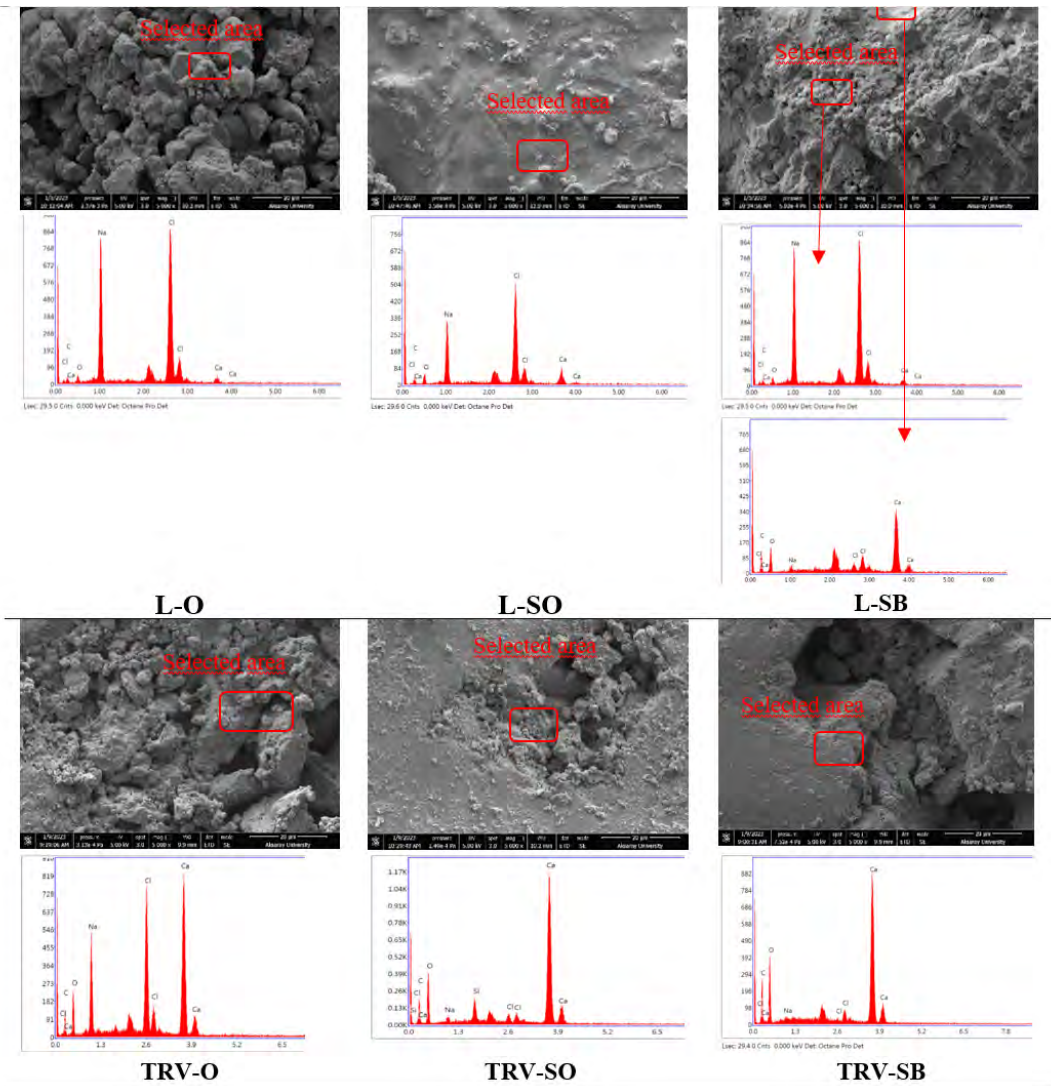
Fig. 13. SEM and EDX images of water-repellent and non-water-repellent samples after thermal shock

In the study, SEM analyses were conducted as well as EDX analyses (Figure 13) to detect the micro presence of NaCl crystals on rock surfaces identified macroscopically after thermal shock experiments with salt solution that were performed for 20 cycles. In the EDX analyses, a significant amount of NaCl crystals were observed in the L-O and TRV-O samples on which water-repellent was not applied. In the L-SO and TRV-SO samples on which solvent-based water-repellent chemicals were applied, Na and Cl peaks were lower than in both the samples on which water-repellent was not applied (L-O, TRV-O) and the samples on which water-based water-repellent chemicals were applied (L-SB, TRV-SB). It was observed that the samples treated with water-based water-repellent chemicals lost their hydrophobic property due to the salt effect. This was particularly pronounced in the L-SB sample. In the region where the chemical lost its hydrophobic property, Na and Cl peaks were higher, while in the analysis performed over the water-repellent chemical, Na and Cl peaks were observed to be lower.
